**REPAIR AND STRENGTHENING OF PRE-1970
REINFORCED CONCRETE CORNER BEAM-COLUMN JOINTS
USING CFRP COMPOSITES**

In Partial Fulfillment
Of the Requirements for the Degree
Doctor of Philosophy in the
School of Civil and Environmental Engineering

Georgia Institute of Technology
August 2008

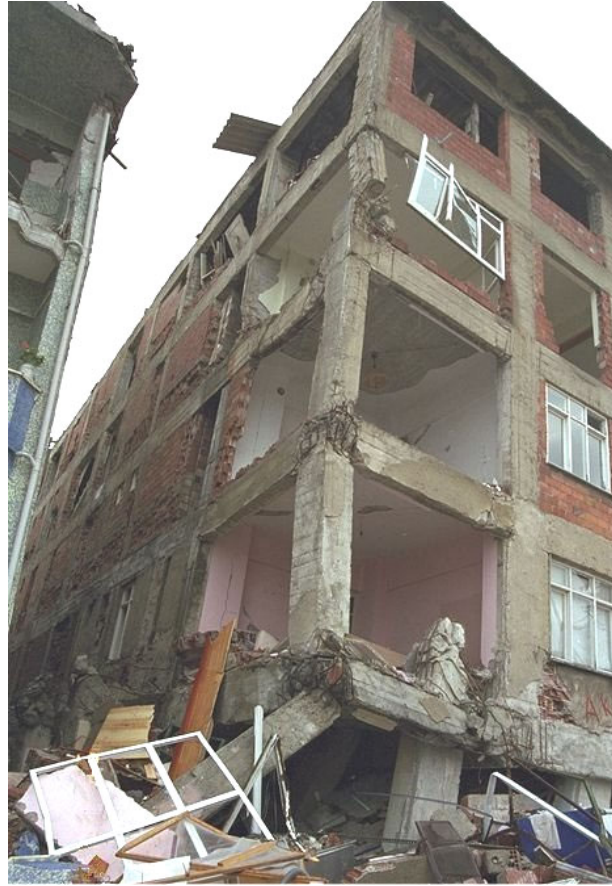
Figure 2.2 — Corner joint failure in 1999, İzmit/Turkey earthquake.
(Courtesy of National Information Service for Earthquake Engineering,
University of California, Berkeley)

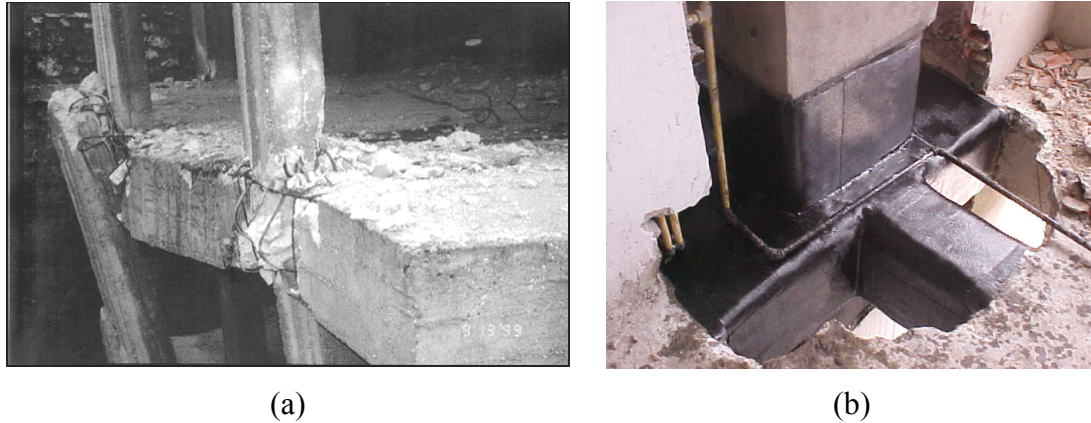
Figure 6.1 — (a) Beam-column joint damage in 1999 İzmit, Turkey earthquake [6.1], and (b) a CFRP retrofit implemented in construction with massive operations [Jorge Rendón, personal communication, 2007].

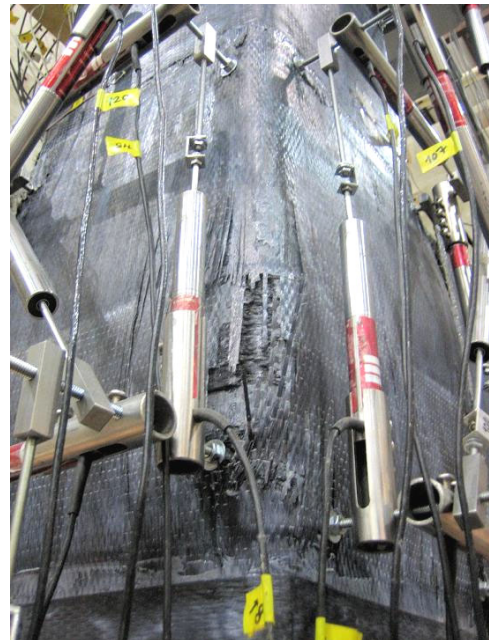
(d) Joint SW corner

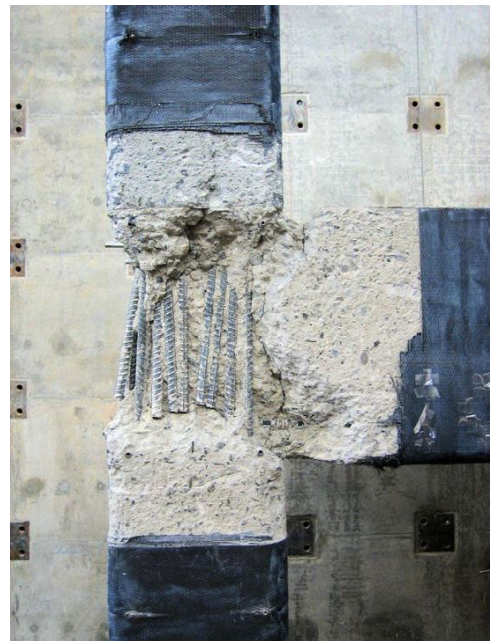
(h) Joint after removal of loose concrete
